**INTERNAL RESISTANCE TO CORROSION
IN STEEL HOLLOW SECTIONS**

Notice 1059

Rapport final
10 B 78/3

**CIDECT
Final Report 10B-78/3**

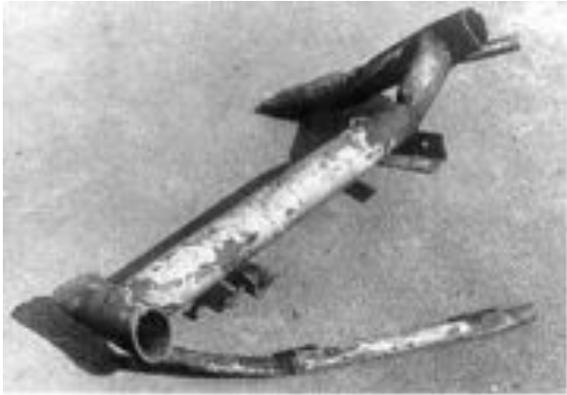
Figure 1: Joint unit with parts of the chords showing severe deformation and rupture at the point of impact.

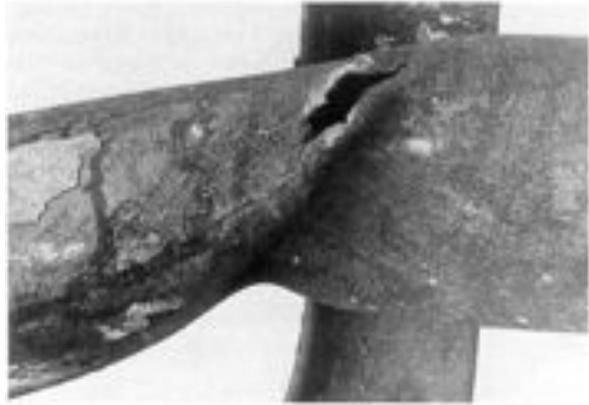
Figure 2: Detail of the rupture at the point of impact showing the ductile fracture.

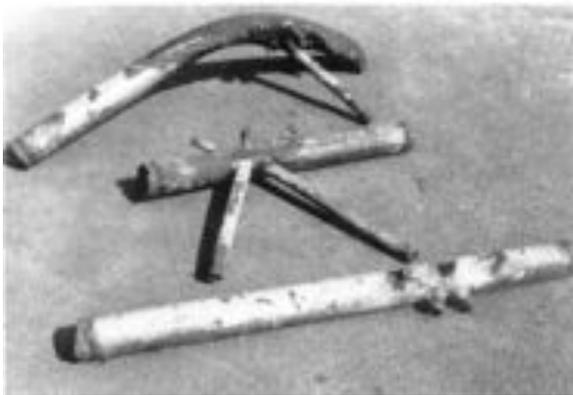
Figure 3: Various parts of the twisted and damaged side chords.

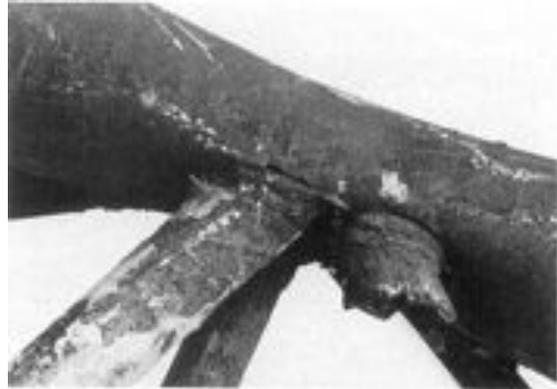
Figure 4: Detail of the upper chord from Fig. 3

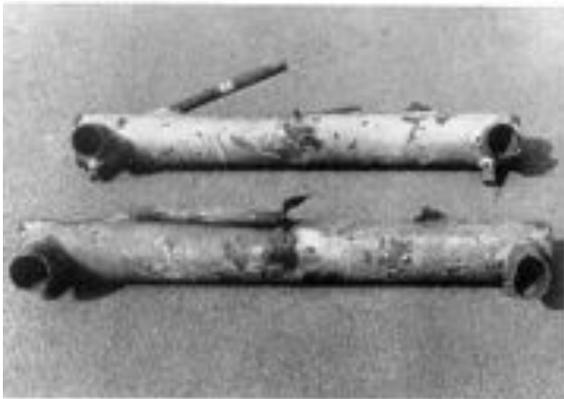
Figure 5: Compressed members with ends still sealed, the ductile bending of the lattice members should be noted.

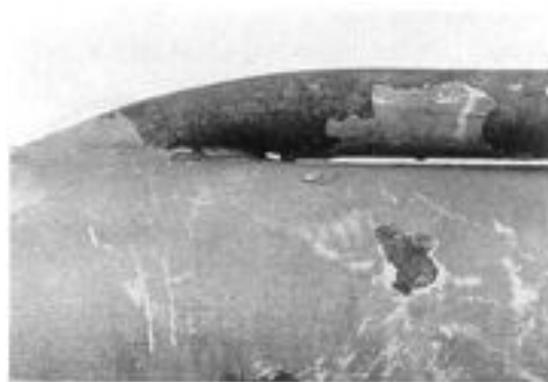
Figure 6: Web member at the bottom of Fig. 5 indicating that the weld has not parted in spite of the large bending force.

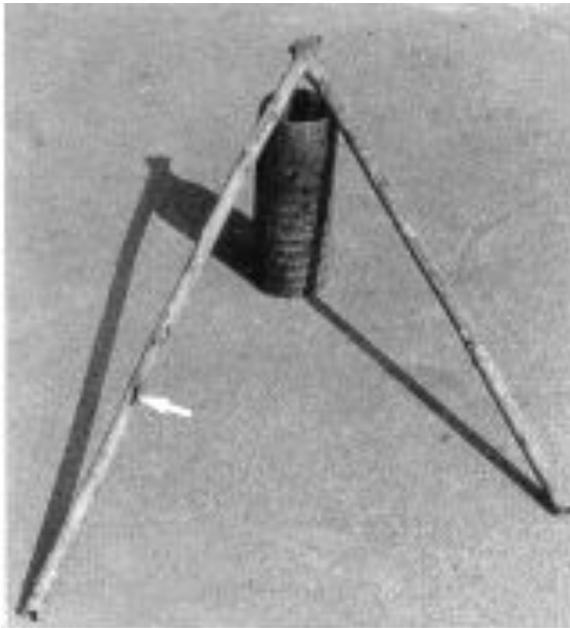
One major case of external corrosion was however observed. This can be seen on the photos, Figs. 7 and 8, where a hole has developed in one of the lattice members. It appears that another component of the framework or even possibly a rope had been in contact with this member causing abrasion which assisted the penetration of moisture, thus intensifying the corrosion. A proper inspection would have made it possible to detect damage of this type.

Figure 7: Perforated member, probably the result of rubbing against another part during its working life.

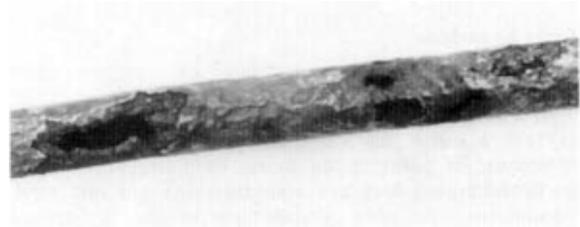
Figure 8: Detail of the corroded openings of the members in fig. 7.

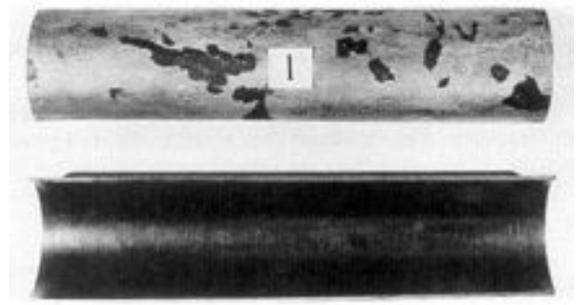
Figure 9: Hollow sections 114.3 mm dia. internal surface: perfectly preserved. External surface paint chipped during handling.

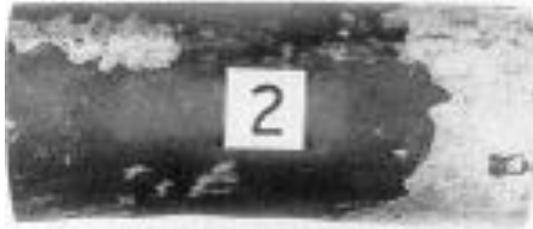
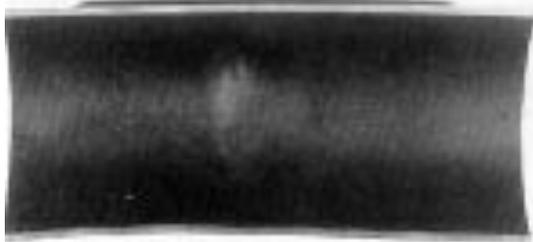
Figure 10: The same part. The traces of pre-welding heating can still be seen intact after 10 years.

It is interesting to note, on Figure 10, the indication of the area heated during the welding operation, visible on the internal wall. Nevertheless no deterioration occurred in this region.

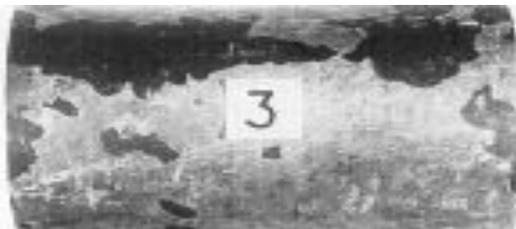
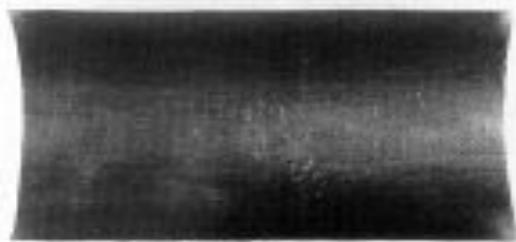
Figure 11: Hollow section 168.3.mm dia internal and external faces

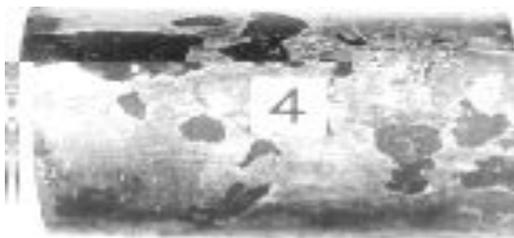
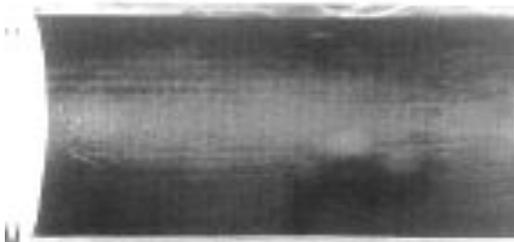
Figure 12: Same component as Fig. 11, the bright appearance of the internal surface should be noted. Some of the original mill-scale adheres to the wall.

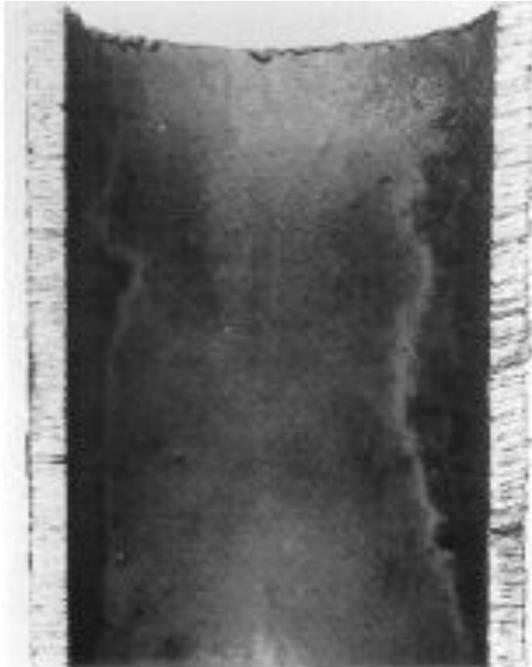
Unfortunately, bearing in mind the size and the weight of the various components, all the cuts had to be made with a torch and very often the resulting flashes soiled the internal faces that were to be inspected. This is why the photos seem to indicate a somewhat rough surface, whereas in fact there was no internal corrosion whatsoever in the davits inspected. The true appearance of the internal surface is better shown at the centre of the section in Figure 14.

Figure 14: Internal surface of the central section of the davit

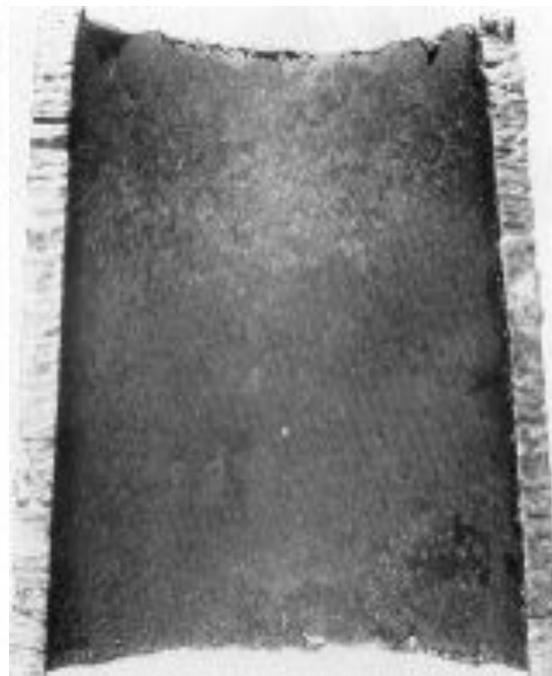
Figure 15: Upper part of the davit post cut open. (note the white spaces and the small spots due to oxyacetylene cutting)

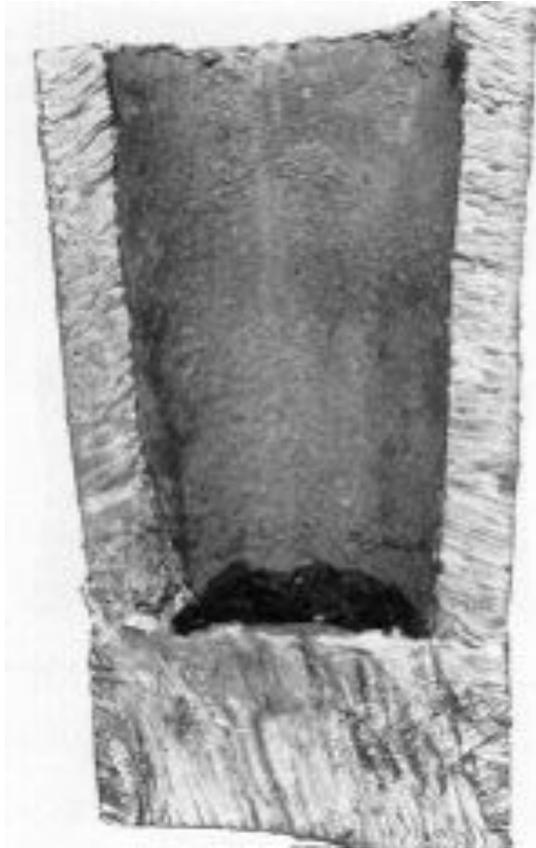
Figure 16: Lower part of the davit post as cut open.
(The white spots are again due to oxyacetylene cutting)

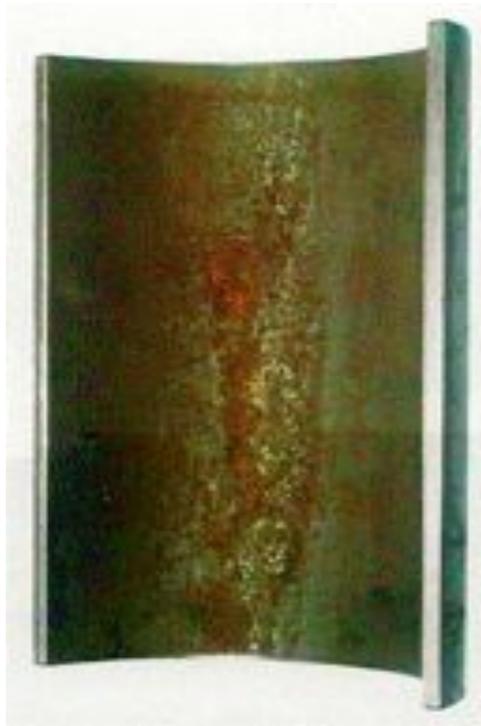
Very slight signs of internal corrosion were observed, other than surface discolouration, due to the oxygen and the humidity in the imprisoned air. Much of the original mill scale was also visible. The slight rusting which was found at the centre of the sample was recent, having appeared after the tube had been cut open for examination.

Figure 17: Circular hollow section 139.7 mm showing one of the half cylinders cut longitudinally. The slight amount of rust in the middle the tube is recent and has appeared since the tube was cut for inspection.

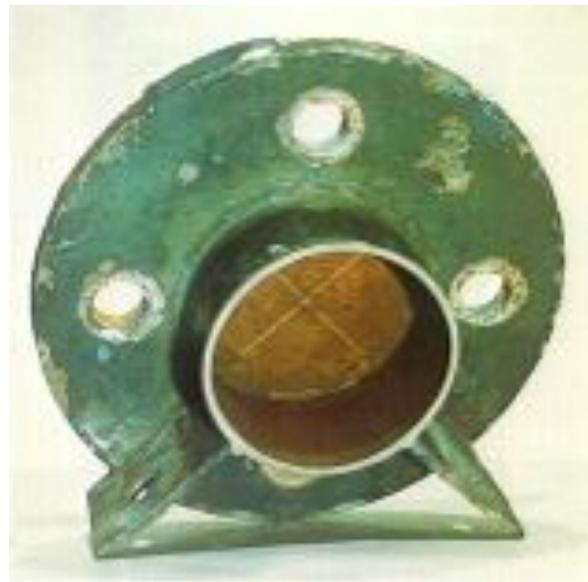
Sample no. 2: Also 159.7 mm dia. included an intermediate flange assembly (Figure 18). The conditions of the internal face of the flange, which had been enclosed and hermetically sealed by being welded to the CHS, was still relatively bright, the original marking-off lines being clearly visible. The intermediate flange assembly was dismantled in order to examine the contact faces of the flanges (Figure 19)

Figure 18: Circular hollow section 139.7 dia. welded to a solid flange showing clean conditions of the internal of faces. The original marking off lines on the flange are still perfectly visible.

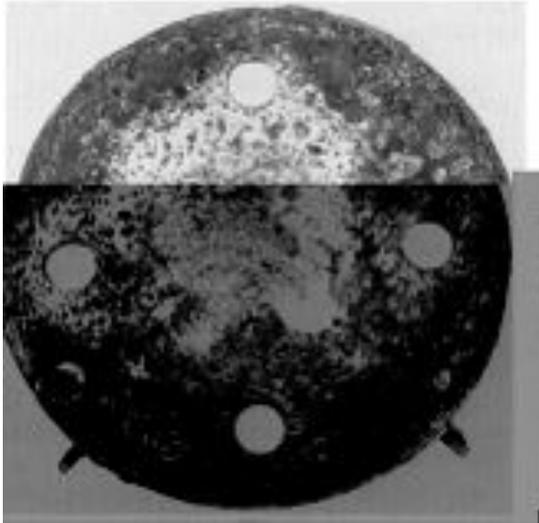
On the outside of the flanges a certain amount of corrosion was discovered, but this was, in fact limited to the area which was outside the pitch circle diameter of the bolts and was obviously due to the progressive ingress of rainwater between the flanges over many years of service (Figure 19).

The amount of corrosion that was discovered was not considered sufficient to adversely affect the strength of the joint. The penetration of water in this manner is a problem normal to all structures which use bolted joints exposed to the weather. The effect can, however, be reduced, if particularly critical, by using jointing material that will seal the connection or by applying mastic between the

Figure 19: Contact faces of the solid flange after dismantling.

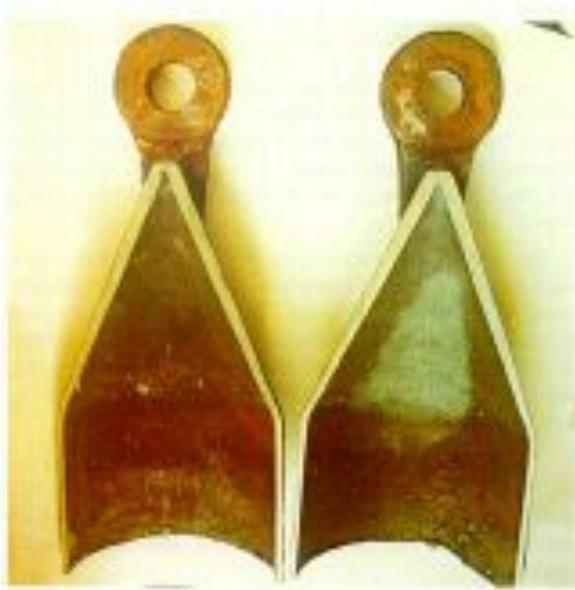
Figure 21: View of the internal faces of the brace component No. 1.

The internal surfaces were perfectly smooth and did not present any sign of corrosion attack. This complete lack of internal corrosion was confirmed by the presence of the mill scale going back to the original rolling of the section, as well as the good preservation of the 'blue' colour due to the heating caused by the welding of the fixing lugs. These observations apply to both the upper and lower ends of the diagonal bracing members.

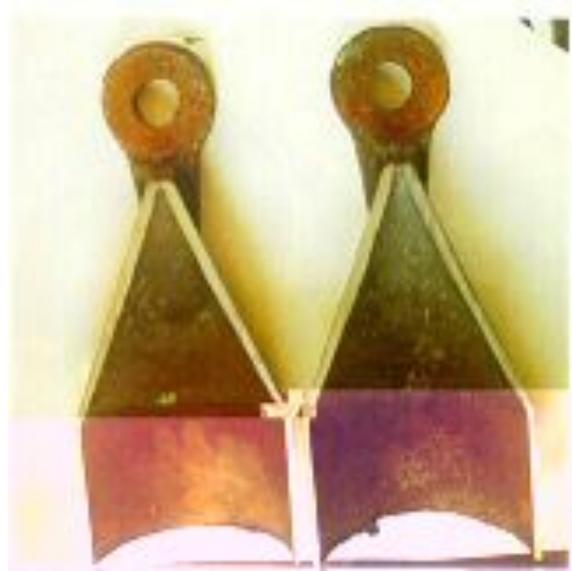
Figure 22: View of the internal faces of the brace component no. 2.

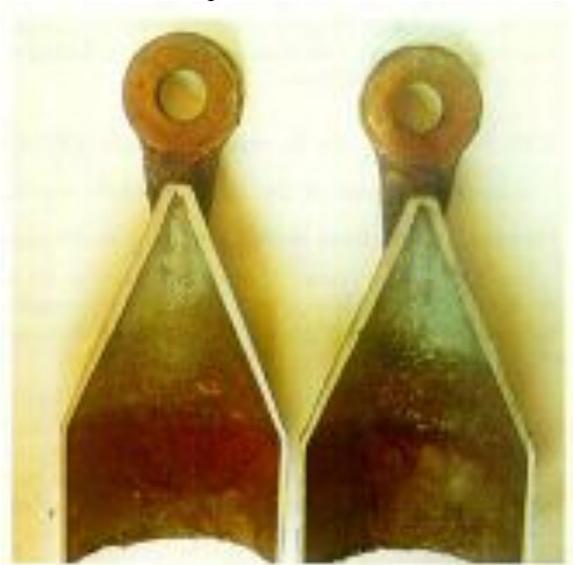
Figure 23: View of the internal faces of the brace component no. 3.

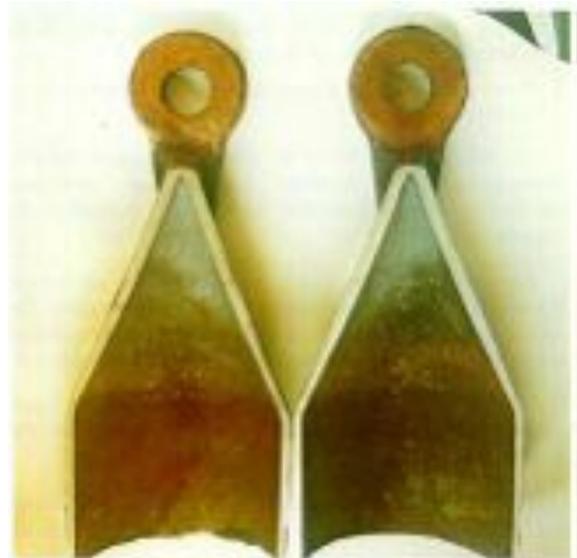
Figure 24: View of the internal faces of the brace component no. 4.

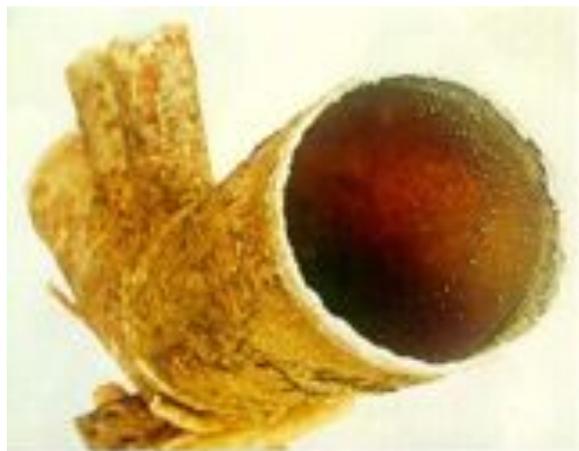
Although external corrosion had caused some holes through the wall thickness at certain localised points, no internal corrosion whatsoever was observed. The original mill scale was still clinging partially to the internal surface.

Figure 25: Truss component located over a pickling bath. The external surface shows an advanced state of corrosion, due to the ambient atmosphere, whereas the inside is well preserved, the traces of damage are entirely due to the oxyacetylene cutting operation.

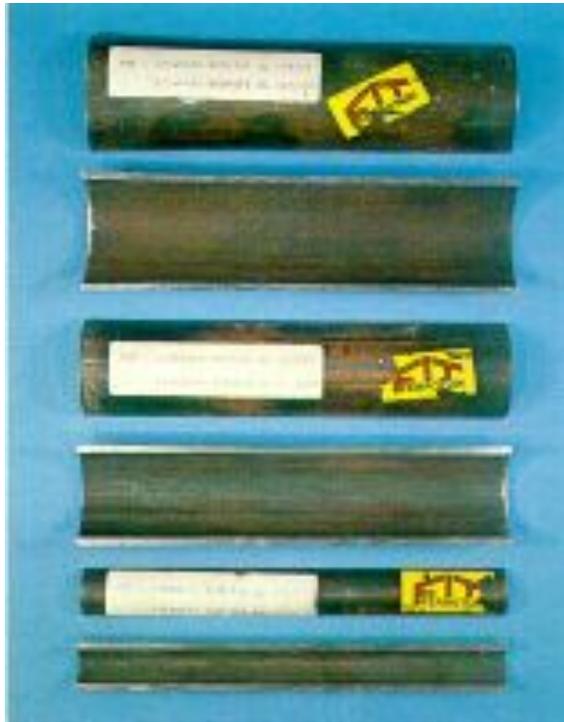
The 3 samples taken from an industrial building had been cut longitudinally and examined (see figure 30). There is no trace of internal corrosion in spite of the age of the structures (more than 10 years) and the conditions of exposure (industrial atmosphere).

Figure 30 - Internal and external appearance of three samples cut from the tubular framework of an industrial building.
