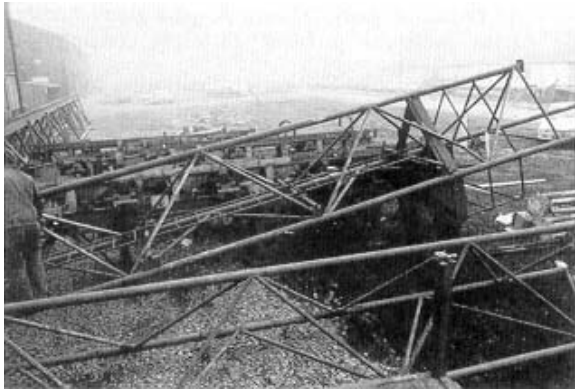
- a) it included a service platform which was badly corroded externally
- b) the access ladder to this platform made it possible to cut out a large number of samples,
- c) one of the three uprights of the leg had suffered an accident several years previously and had remained open over a height of about 1 m.

Figure 33: One of the gantry legs comprising the ladder and access platform which was sent as a complete unit to the LNE.

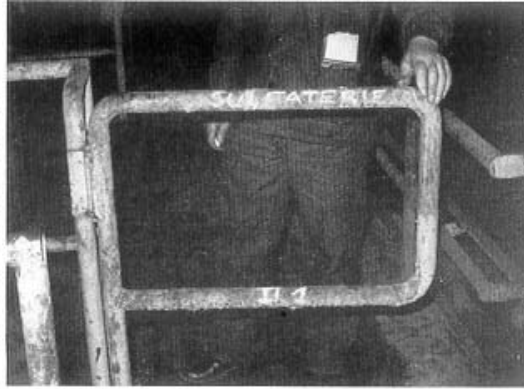
Figure 34: A sample of the railing which had been removed from the sulphate works. Particularly badly corroded externally.

- a) the bracing members of the roof structure. These were hollow sections of 34 mm external diameter flattened at both ends and in the centre for bolting purposes
- b) the lower rail of the bannister which had been sealed at both ends by welding and whose external appearance showed an advanced stage of corrosion (see Fig. 34)

The railing sample from the vicinity of an acid bath showed an external surface which was excessively corroded. On the other hand, this member, sealed by welding at both ends, had kept its original internal condition with remains of the mill-scale. The contrast between the two faces of this sample was particularly significant; the sealed interior is protected whatever the external atmosphere.

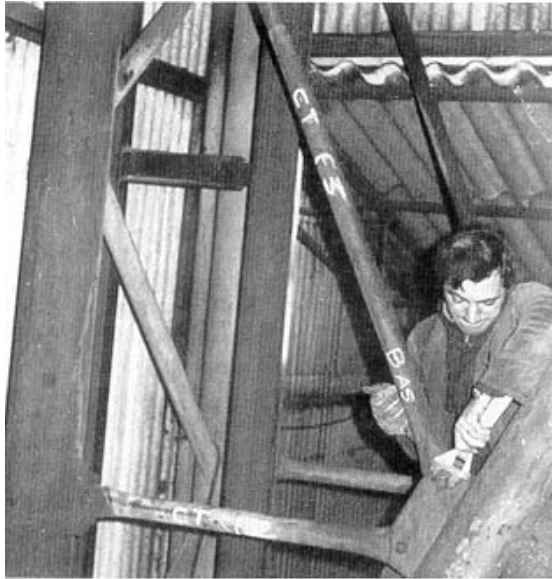
- a) From the roof, a lattice purlin comprising an upper chord in hollow sections 45 mm square and a lattice in CHS of a smaller diameter
- b) From a stabilising portal frame (see Fig. 35), two units of bolted lattices, which had been dismantled. These had been joined at their flattened ends.

Figure 35: Dismantling of two bracing members with flattened ends.

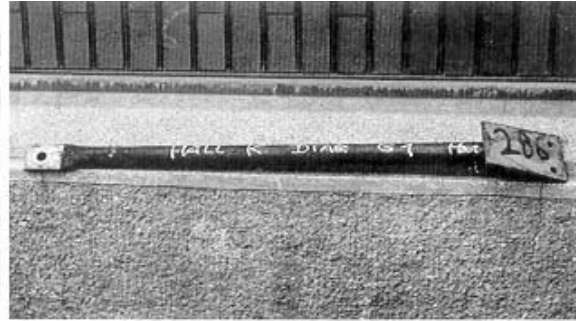
4) Factory shed - gable type wind girder: This building, constructed in 1958, had components which had been exposed to the industrial atmosphere since that date. One sample only was taken, namely a wind girder support (see Fig. 36). This strut was bolted at the top through a welded plate and at the bottom simply by flattening.

Figure 36: Diagonal member flattened at one end and welded to a plate at the other.

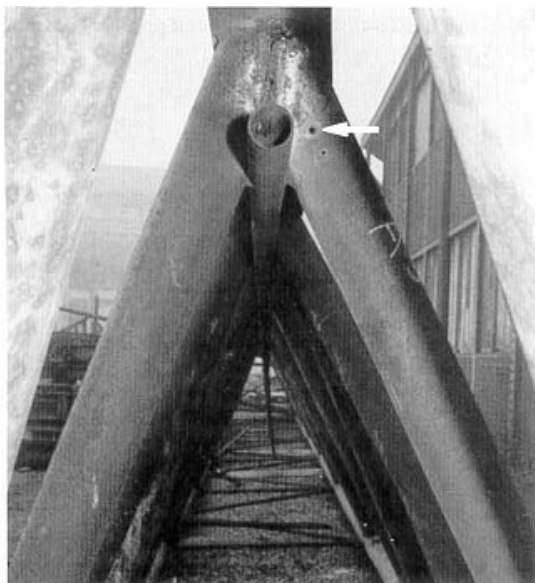
a) Horizontal girder: 5 diagonal members were taken as samples. All of them were sealed by welding and their internal condition was perfect. Member A31, however, deserves to be dealt with at greater length (see Fig. 37). This member featured 2 holes, for attaching insulators, which had remained open for several years. Corrosion was discovered in the immediate vicinity of the 2 holes, but the corrosion was strictly limited to that area. The internal face of the rest of the member was intact.

Figure 37: Lower part of the A3 diagonal member showing the two attachment holes (note that the triangular girder is resting upside down)

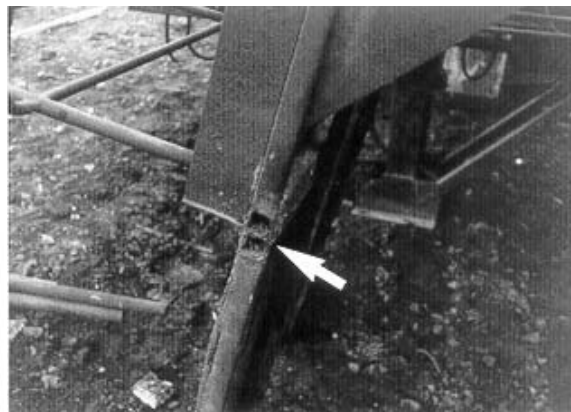
Figure 38: Platform with RHS stiffening. Only the longitudinal members with sealed ends have kept a corrosion-free internal surface.

The cross members were open at both ends and their internal faces were in an advanced stage of corrosion. The longitudinal members which were welded at right angles to the transverse ones, and were thus sealed at both ends, had internal faces which remained in an absolutely perfect state. On the whole of this leg structure, 25 of the 36 members, which were examined, were in a perfect condition internally. Of the 11 members which had suffered corrosion, 4 were open at both ends and 7 had deteriorated either at the beginning or during their working life.

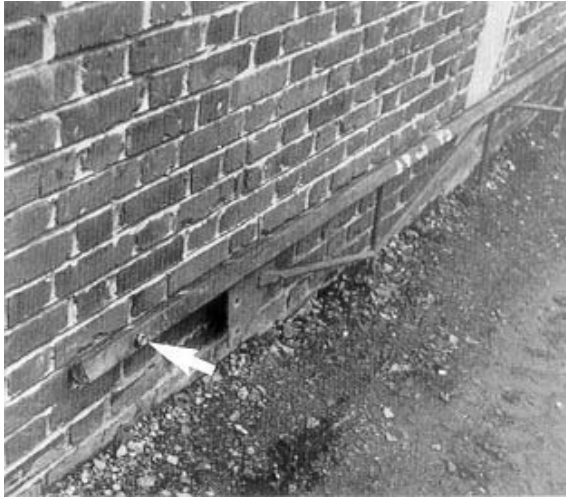
Figure 39: End of a lattice purlin with a bolt hole through the chord.

3) Storage hall - eastern extension: The lattice purlin included an upper chord member in square RHS sealed at both ends, but drilled through for bolting. The bolt had blocked the hole, apart from clearance, and it is interesting to note that some of the original mill-scale fell from the hole when the bolt was removed. (See Fig 39)

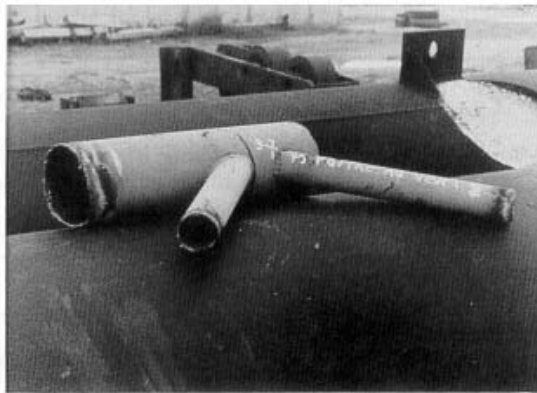
This chord consists of a seamless CHS with an external diameter of 168 mm, positioned horizontally and sealed at both ends by end plates. The sample includes a node point where two diagonal bracings meet the chord. These are continuously welded tubes, measuring about 76 mm and 70 mm in diameter, and have also lain horizontal for at least five years. The latter were sealed at their ends by the chord member to which they were welded.

The internal surface of the chord is covered, as is normal, by a uniform superficial film of rust, which cannot affect the integrity of the structure. The internal surface of both diagonal members remained in a satisfactory condition (original mill-scale and superficial rust) (1).

Figure 48: Wind girder 3. Sample removed.

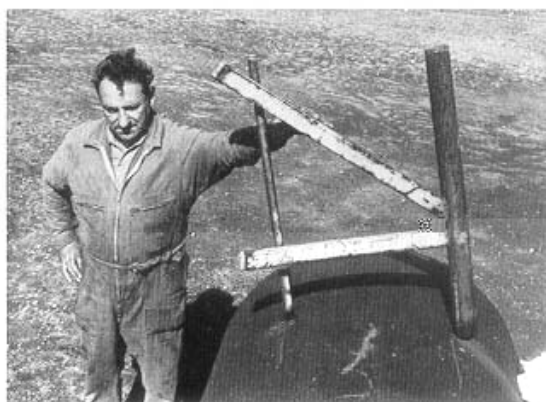
The sample delivered to the laboratory (Fig. 50) was about 850 mm long, cut from one end of one of the two gangway guardrails. It consisted of a longitudinal rail and secondary rail connected by two diagonal members in hollow section. The rail and secondary rail consisted of two seamless circular hollow sections of 70 mm and 76 mm approximate external diameter respectively, horizontal and open at the ends. The sample includes the node point of the two seamless 50 mm RHS diagonal members, which were sealed at their ends by being welded to the external face either of the rail or of another hollow section; one is laid in a vertical position and its external wall is welded to the external wall of the secondary rail, the other is in a sloping position.

The external face of the two circular hollow sections is covered by an anti-rust paint of a red colour, which has suffered considerably. This surface has been pitted by corrosion. The internal walls of these hollow sections, which were open at the ends, are relatively uniformly affected by corrosion (1).

Figure 50: Gangway 4 - Cut sample

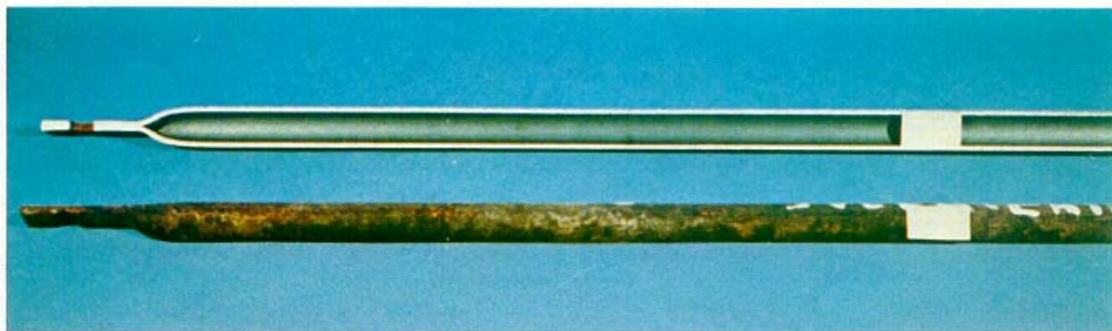
Figure 57 shows a circular tube sealed by flattening at the ends; its internal surface has remained in a satisfactory state in spite of the corrosion on the external surface.

Figure 57: Flattened end tube (First inspection programme)

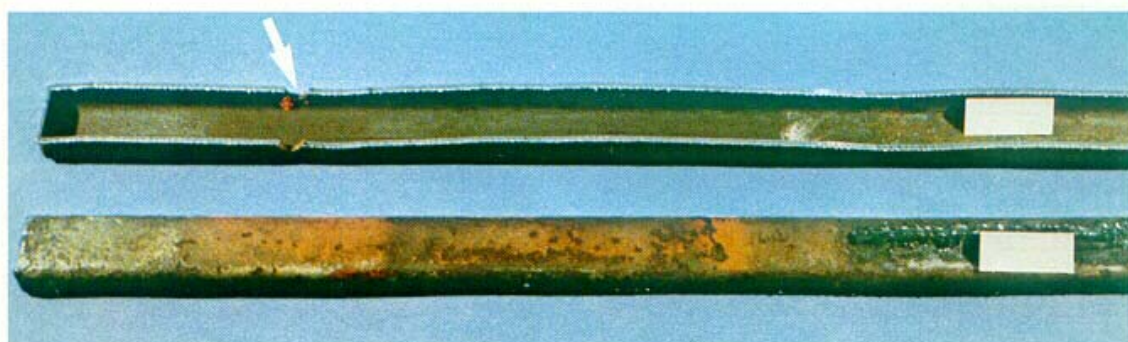
The original mill-scale was found to be virtually intact in the case of a hot-finished RHS whose ends had been sealed (Fig. 58) by being welded at one end and bolted at the other.

Figure 58: Tube with closed ends, one of which is bolted (First inspection programme)

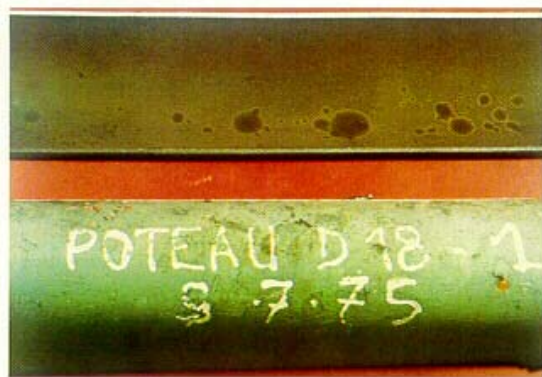
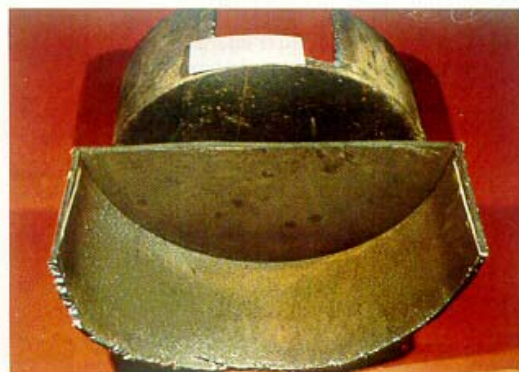
Figures 59 and 60 represent two tubes of more than 90 mm diameter; one is a circular seamless tube with its ends welded to the external face of another tube, the other is a circular welded tube whose ends were welded to end plates. In each case, the internal surfaces are covered, as normal, with a thin coating of rust which could not affect the performance of the structure.

Figure 59: Tube with ends welded to the wall of another tube (Second inspection programme)

Figure 60: Tube with ends welded to a bottom plate (First inspection programme)
