**INTERNAL RESISTANCE TO CORROSION
IN STEEL HOLLOW SECTIONS**

Notice 1059

Rapport final
10 B 78/3

**CIDECT
Final Report 10B-78/3**

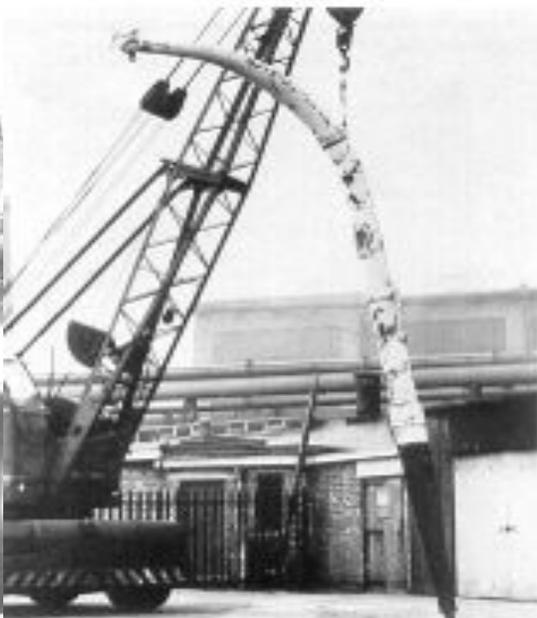
Figure 13: Complete S. S. Aquitania davit as delivered for inspection

These davits were then about 37 years old and had been exposed to a marine atmosphere for the greater part of their lives. As can be seen in the photo (Fig. 13) each davit is made of tube approximately 406 mm diameter and 52 mm thickness, cylindrical at the centre and conical at each end, where the diameter is reduced to about 170 mm. Both ends are sealed by welding, one with a steel ball to carry the lifeboat and the other by means of a circular plug in mild steel. The total length was about 9 meters. One of these davits was cut with the flame cutter so that the interior could be examined.

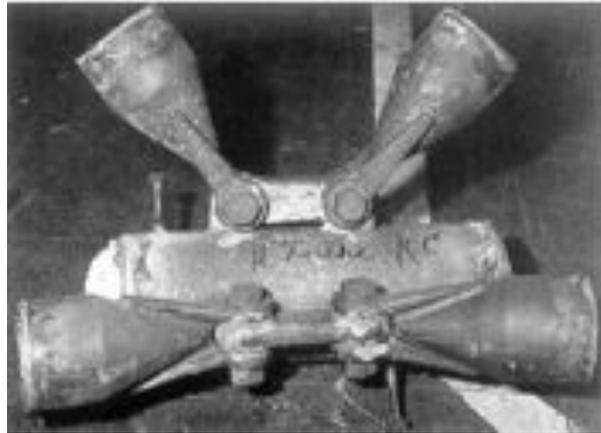
Figure 20: High voltage transmission tower. External view of the cut out joint sample.

Result of the examination: Figure 20 shows the part of the pylon which was supplied by Mannesmannrohren-Werke. This sample had been cut out of a joint situated some 12 m above the ground.

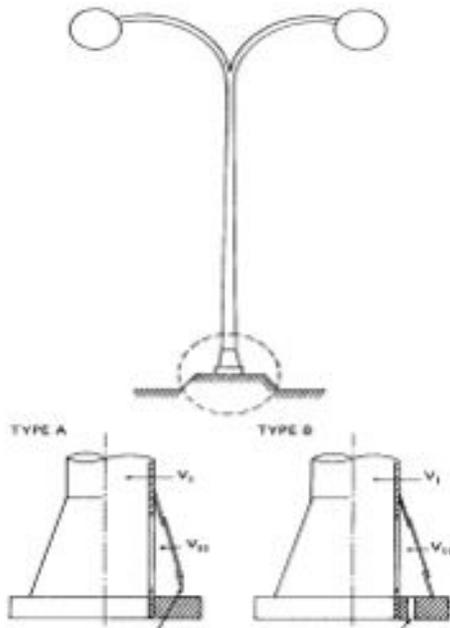
Structure: This document refers to the investigation carried out on the internal corrosion of lighting columns for public thoroughfares with a high level of traffic (Figure 26).

Figure 26 - Urban lamp-post: water drainage hole 10 mm radius for both types
 Type A: side hole Type B: base hole

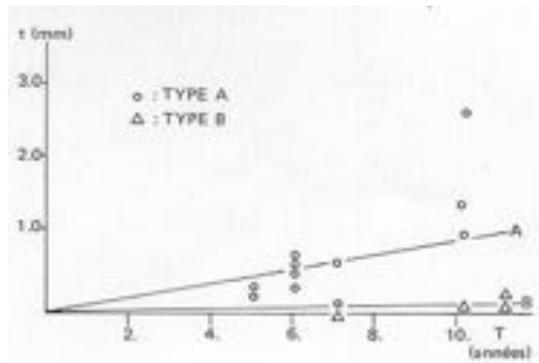
Result: The relation between t (thickness reduction due to internal corrosion) and T (years elapsed since installation) are shown on Figure 28 for two types of water drainage holes.

Figure 28: $-t/T$ ratio in relation to the type of drainage hole (years)

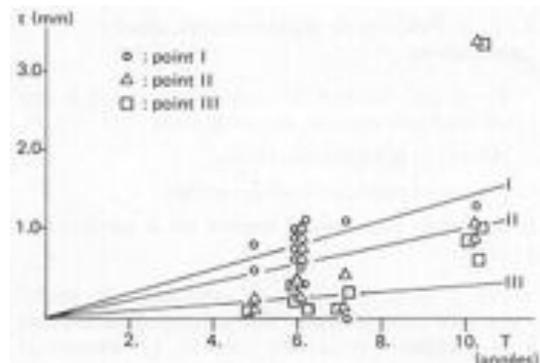
Figure 29: Type A column. t/T ratio in relation to the measuring points (years)

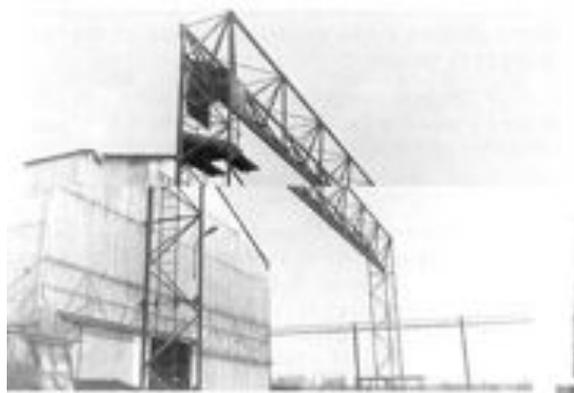
Figure 31: Valenciennes Works -General view of the loading portal before dismantling.

1) External loading gantry: This gantry (see Fig. 31) had been used for mechanical handling and for loading the structural components fabricated in an adjacent workshop. It had been erected in 1962, and had not been used since 1970, so it was due for dismantling. This is the reason why the highest number of members cut out came from this structure. The working and maintenance conditions for this gantry were those which are commonly encountered in metal workshops of the Valenciennes region, i.e. an industrial atmosphere and severe climatic conditions, being exposed to the weather.

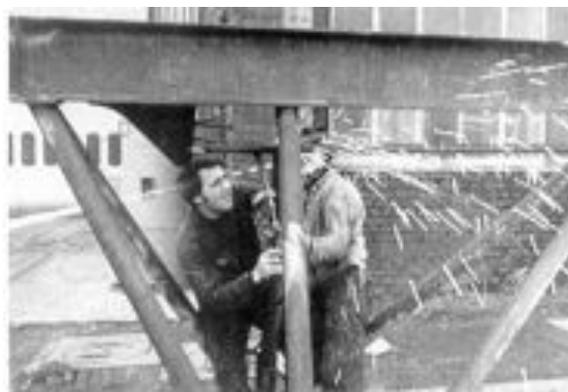
Figure 32 - Cutting out of a sample

Samples were cut out from the horizontal girder after it had been dismantled (see Fig. 32). Among these members 1 had 2 fixing holes for electric insulators which had been removed four years previously. The two holes, about 8 mm in diameter and some 50 mm apart, had never been plugged.
