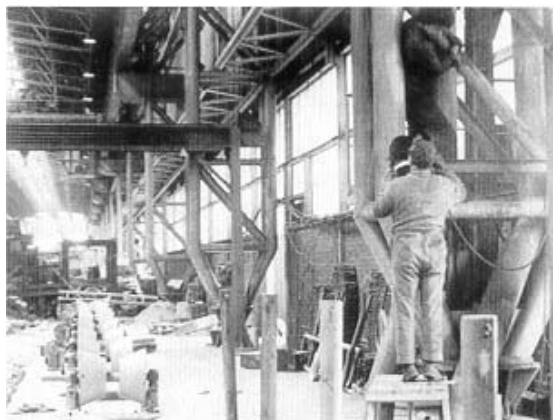
Figure 40: Hall III, Row B. Column D-18 and general view of hall.

Column of Hall III: The hollow section marked "Column D-18-I" was cut from the horizontal bracing of a crane rail stanchion in No. 2. tube mill after more than twelve years in an industrial atmosphere. This stanchion numbered "D-18 row B" is shown on Figures 40 to 41. Figure 42 shows the same stanchion after 800 mm had been cut out from the bracing. The sample is shown in Figure 43. It is a seamless circular hollow section about 168 mm external diameter, sealed at both ends where it is welded to the

vertical chords, also of circular sections, taken from stanchion D-18. The external surface, painted green over an anti-rust primer of a red colour, is in good condition.

The internal surface is covered, as is normal, with a thin film of rust which does not affect the integrity of the structure of which the member is a part (Fig .59)

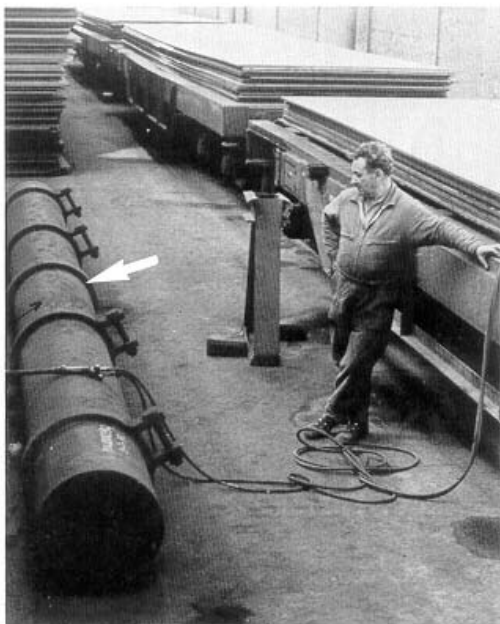
Figure 44: Hall no. 5, lifting beam 2
- General view.

Lifting beam of Hall V: Lifting beam 2, which went into service some 10 years ago, has been stored in No. 5 tube fabrication shop for five years, (Fig. 44)

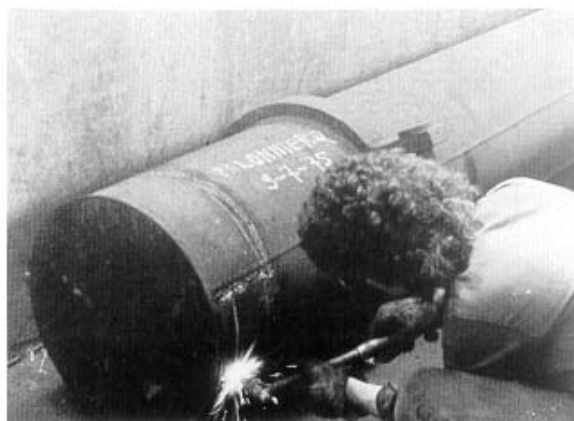
It consists mainly of a circular hollow section welded longitudinally, external diameter about 500 mm by some 6 m long, in a horizontal position with sealing plates at both ends. A sample was cut from one end, approximately 200 mm long (Figs. 45 and 46). The unpainted external surface is uniformly pitted by corrosion. The internal surface, which as is normal, is covered with a superficial film of rust and looks satisfactory (Fig. 60): the marking off lines are still visible on the end plate which still retains the original mill-scale in certain areas (1).

Figure 45: Lifting beam 2 – cutting out of sample

Figure 46: Lifting beam 2. View of the bottom plate at one of the ends.

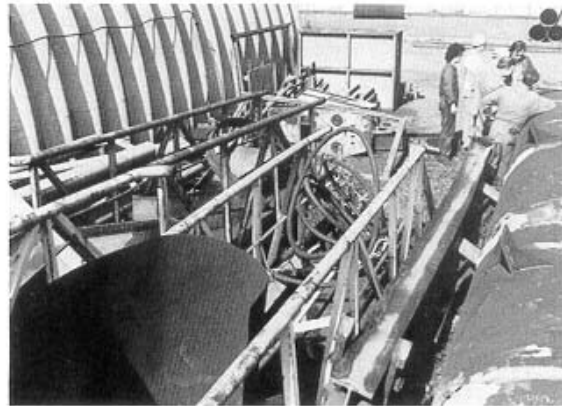
Figure 49: Gangway No. 4. as stored.

Gangway No. 4: This was installed thirteen years ago on line B between halls I and II and ran inside these halls. It was dismantled five years ago and has since been stored outside the building (Fig. 49) in an industrial atmosphere and close to the sea.

The external face of the two circular hollow sections is covered by an anti-rust paint of a red colour, which has suffered considerably. This surface has been pitted by corrosion. The internal walls of these hollow sections, which were open at the ends, are relatively uniformly affected by corrosion (1).

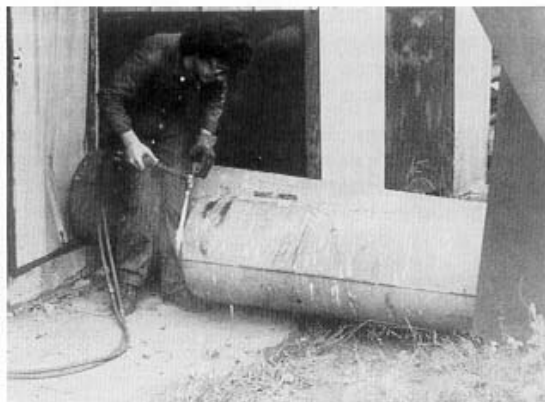
Single tube semi-portal of hall I: The single tube semi-portal No. 5, which was installed in 1962 in hall I, has been stored for three years in the open air, in an industrial atmosphere not far from the sea (Fig. 51). We are dealing here with a longitudinally welded circular hollow section 460 mm in diameter, and some 6 m long, bent in the middle. It was originally in a vertical position but has been lying in a horizontal position for three years. Both ends are sealed, welded to a plate. The laboratory sample (Fig. 52) about 100 mm long, had been cut from one end. The external surface is painted yellow over an undercoat of red anti-rust paint, and has a satisfactory appearance. The internal surface is covered, as normal, with a thin film of rust which cannot affect the quality of the hollow section, or indeed that of the structure (1).

Figure 51: Hall I: single tube semi-portal.
Cutting out of the sample

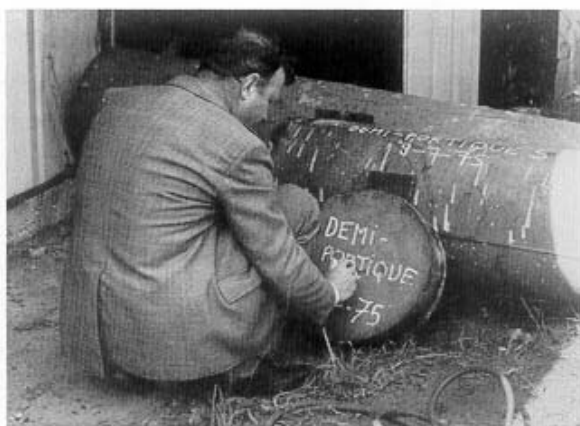
Figure 52: Single tube semi-portal. Cut sample

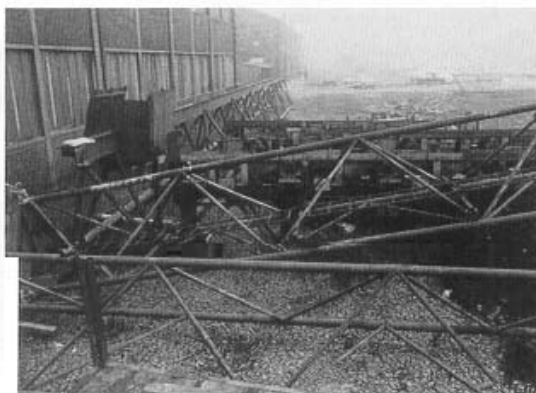
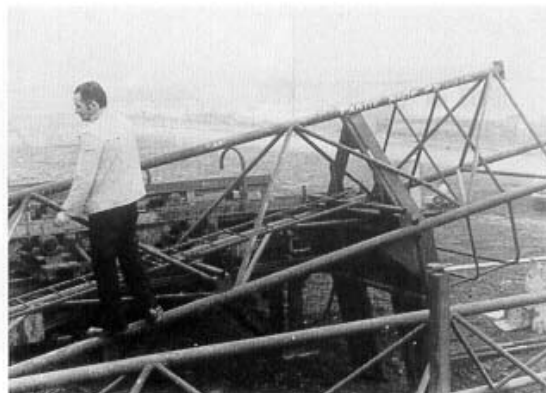
It was observed, as could be expected, that the 45 hollow sections which showed no alteration inside were those whose ends had been suitably sealed when installed. Some of them had been in place for more than thirteen years in a particularly hostile industrial or marine atmosphere, being:

on the outside of the buildings (Figs 54 and 55),

Figure 54: View of lattice column in storing area (first programme)

Figure 55: View of lattice column in storing area (first programme)

The substantial internal deterioration in one of the tubes in Figure 61 is due to the open weld over this part of the section which exposed the interior to the hostile external environment. On the other hand, the other tube in Figure 61, which was properly sealed in the same environment (column of Figs .54 and 55), has a satisfactory inside appearance.

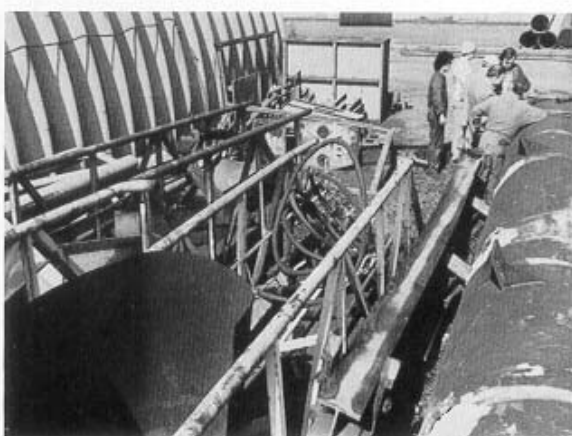
along side the sea (Fig. 56),

Figure 56: View of the samples in storing area (second programme)

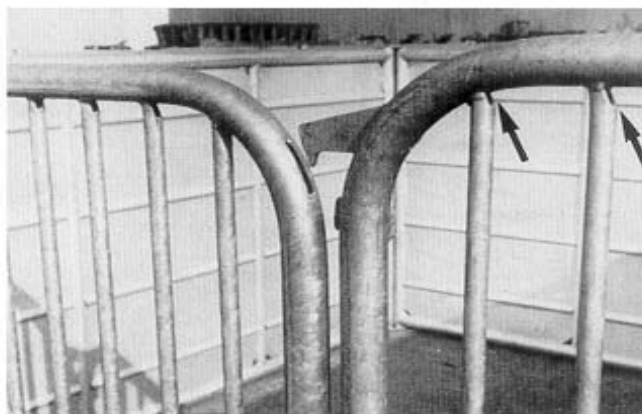
Figure 66: This partition fence in a cattle rearing installation has been galvanized after fabrication. Note the openings at the ends of the vertical infills (arrowed).
